From Myford Technical Support 01/004
Dec 2010

Better Beds and Saddles.

Follow a Myford Lathe Rebuild

New Lathes For Old

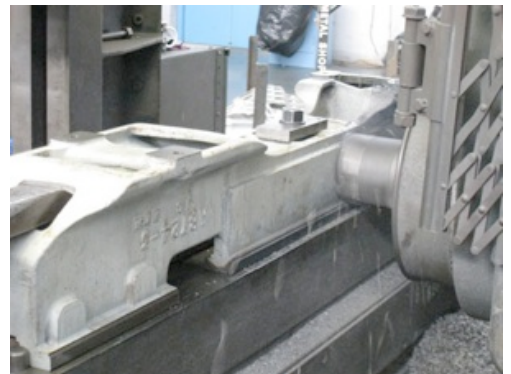
The bed that didn't make it

This involved an early Super 7 bed which was originally despatched, as a new lathe, from our works in late 1953. It was returned to us in 2007, after 50 odd years of continuous use. In came the bed with saddle and all associated parts. The owner earnestly requested a bed and saddle regrind but unfortunately we were unable to help.

What caused the problem with this particular request was a dent in the bed approximately 0.075" (1.9050mm) deep and, of course, outside of the limits. All was not lost we were able to source a pre-owned bed which we regrind and matched to the existing saddle. This lathe is still performing well today.

Many Bed and Saddle regrinds, and re-regrinds are carried out every year and nearly all fall within limits. The saddle also has its limits inasmuch as lubrication can become ineffective when the oil grooves become narrowed by heavy wear of the slide faces, something to be aware of if regrinding yourself.

Two points are clear, there are times when wear is beyond recovery – and one bad component doesn't write off a lathe provided the work of repair is correctly carried out and inspected to reaffirm original standards have been restored.

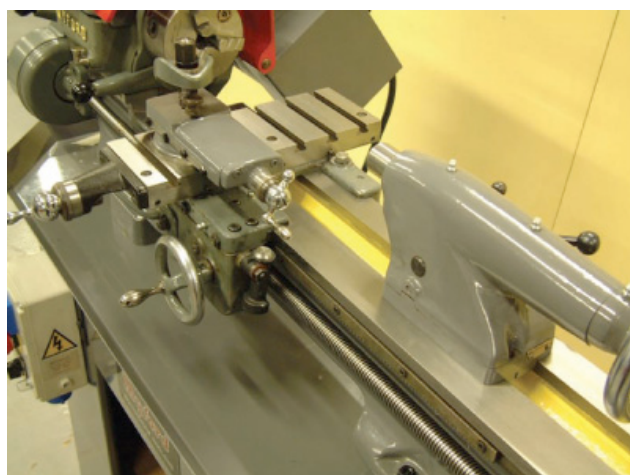
The Myford Super 7 lathe selected for refurbishment. It appeared to have suffered more from mis-use than wear

Examination and initial dismantling of the machine revealed where reworking would be possible and where replacement parts would obviously be required (**Photo 2**). Subsequent checks at the re-assembly stage could also result in the need for new components. The initial list of replacements was:-

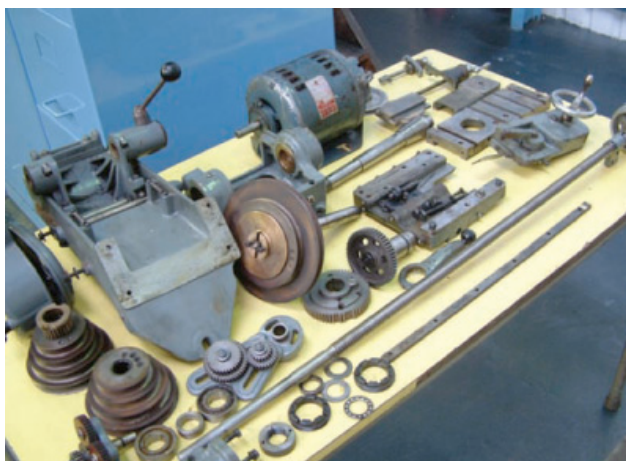
Photo 2

A selection of the components laid out for examination prior to rework

- Bull wheel
- Back-gear cluster
- Rear spindle bearings
- Sleeve gear

Feed nuts
 Feed screws
 Top slide base and gib strip
 Top slide tool clamp (stud)
 Tailstock cam and eye bolt
 Drive belts
 Felt wiper for saddle
 Lubricating wick for spindle bearing

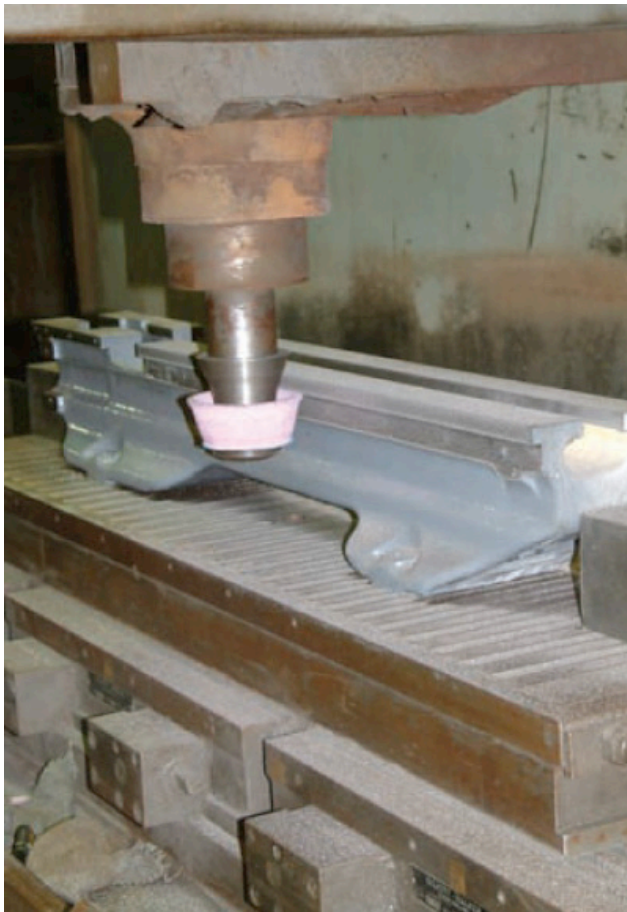
Photo 6

Grinding the underside of the bed shear

To complete the bed rework it was now passed to Garry Alton who would grind the under faces of the shears, using a slidaway grinder equipped with a vertical spindle. At this point gremlins appeared, it being evident that the machine was not operating correctly. Returning from witnessing another operation, we found that the problem had been pinpointed to a main drive motor, the only solution being a complete re-wind. Garry therefore had to set up another machine (a Thompson/Matrix grinder) and prepare a grinding wheel to suit. The result can be seen in **Photo 6**.

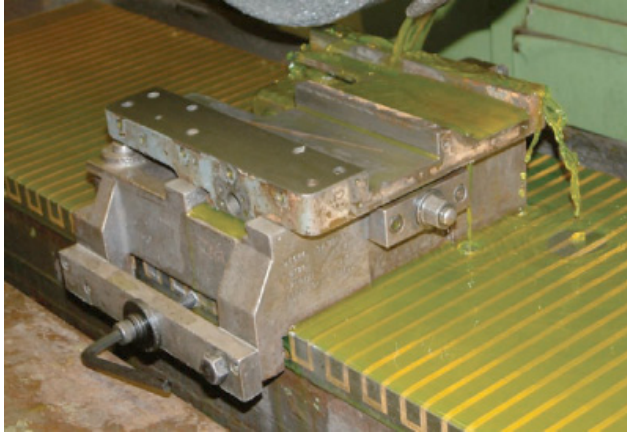
Photo 7
The saddle is mounted off the cross-slide dovetail to re-grind the under surfaces

The next component to be reworked was the saddle. The fixture mounted on a Magerle surface grinder locates the crossslide dovetail (**Photo 7**), allowing the faces which bear on the top and side surfaces of the bed shears to be restored, ready for scraping at the fitting stage (**Photo 8**). This is, perhaps, an appropriate point to emphasize that Myford consider it essential that, if a bed re-grind is carried out, then the saddle must also be ground and scraped to fit. Although the problems with the sideway grinder had caused the saddle to be ground before finishing the bed, it was possible to illustrate this need by trying another worn saddle on the newly ground bed. The minimal contact can be clearly seen (**Photo 9**) and it is not practical to improve this to the required level simply by scraping. The large area of contact achieved after grinding and scraping can be seen in **Photo 10**.

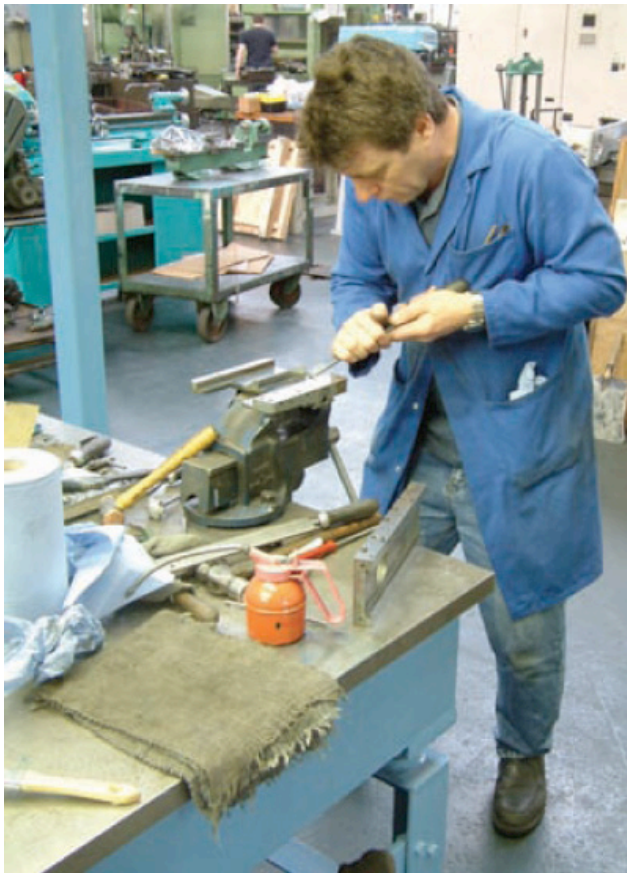
Photo 8
Brian McKechnie scrapes the underside of the saddle to produce a good bearing surface

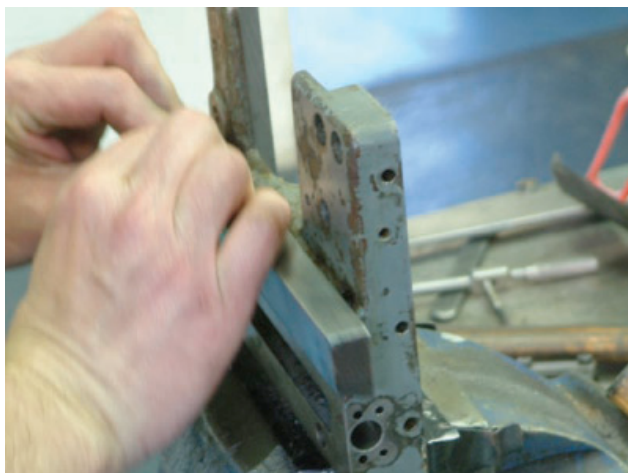
Photo 11

The dovetail on which the cross-slide runs is checked against a master

gauge and scraped to fit as necessary

After grinding the top faces of the crossslide and top slide, these items were fitted to their mating components by scraping (**Photos 11, 12 and 13**). This now made it possible to fit the saddle to the bed. With a jig clamped to the bed and the saddle secured so that the 'fast' edge was located against its mating bed shear, the movement of the cross-slide could now be checked (**Photo 14**). The requirement is that the movement towards the headstock should be 0.001in. in 12in., ensuring that facing cuts will produce a slightly concave surface. This requirement was met by scraping the fast edge of the saddle to suit.

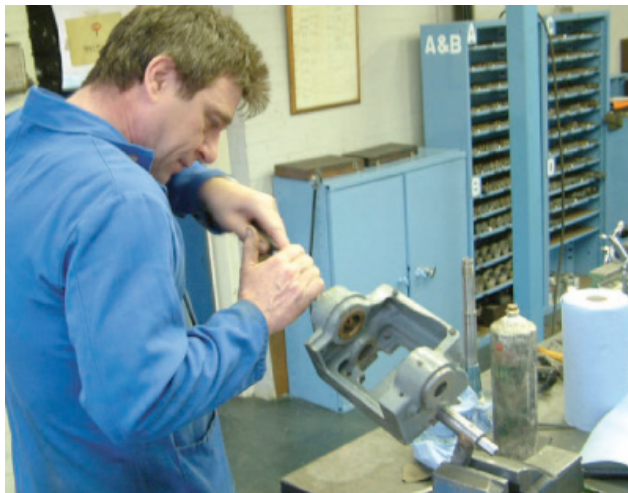
Photo 15
Brian McKechnie re-fits the front bronze taper bearing by scraping

While other components were being remachined, Brian McKechnie had made a start on the headstock. With a dummy rear bearing in place, the front bearing taper was scraped to the required fit (**Photo 15**). Examination of the spindle indicated that both the nose thread and the Morse taper socket were in an acceptable condition. It is possible to correct minor imperfections in both areas. The thread can be re-chased to bring it back to original tolerances and the taper can be lightly reamed to improve the surface. There was, however, some marking on the shaft in the area of the bull wheel location that gave cause for concern. As soon as the bed assembly was available, the headstock was fitted and checks carried out on the concentricity of the nose spigot and the bore of the taper and the swash on the location face. These proved to be unacceptable, indicating that the spindle was bent – a somewhat rare occurrence, I was assured. This resulted in the decision to fit a new spindle. This damage, coupled with the fact that there were no teeth left on the smaller gear of the back-gear cluster (**Photo 16**) and quite a few missing from the bull wheel, suggested to me that the back-gear had been engaged while the lathe was running – an old schoolboy prank!

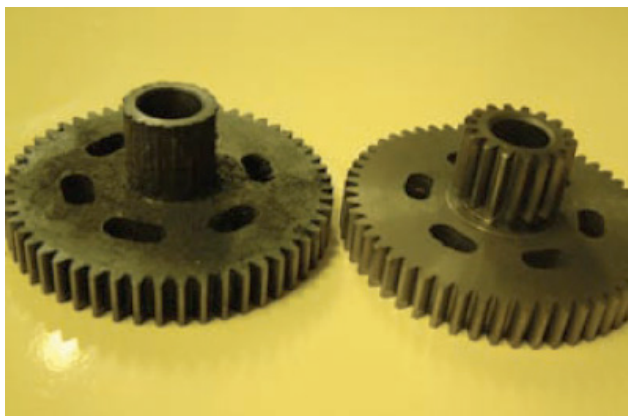
Photo 16
The old with the new. The back gear cluster had suffered badly, with no teeth left on the small pinion. The bull wheel was also short of its full complement, as can be seen in *Photo 2*

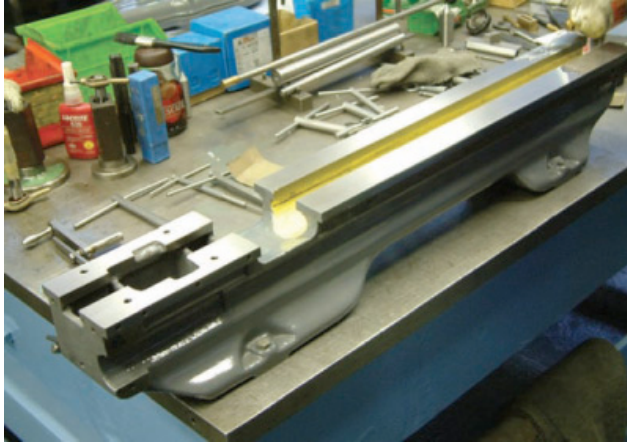
Photo 17

The bed seen set up on a flat surface for assembly checks to be carried out

Once this problem had been eliminated and with the bed set level (**Photo 17**), it was possible to carry out the remainder of the setting checks, using

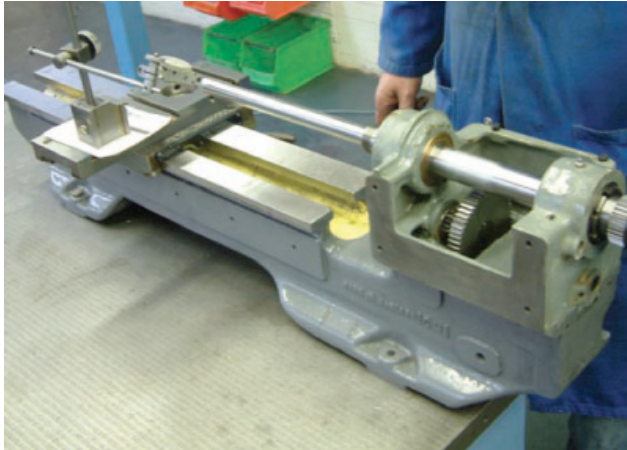
Photo 18

The first alignment checks with a Morse taper test bar set in the spindle

In each case the measurements were within, or close to, the errors permitted by the new-build Inspection Report. Where there were minor discrepancies, these were corrected by scraping the bottom face and/or tenon of the headstock casting.

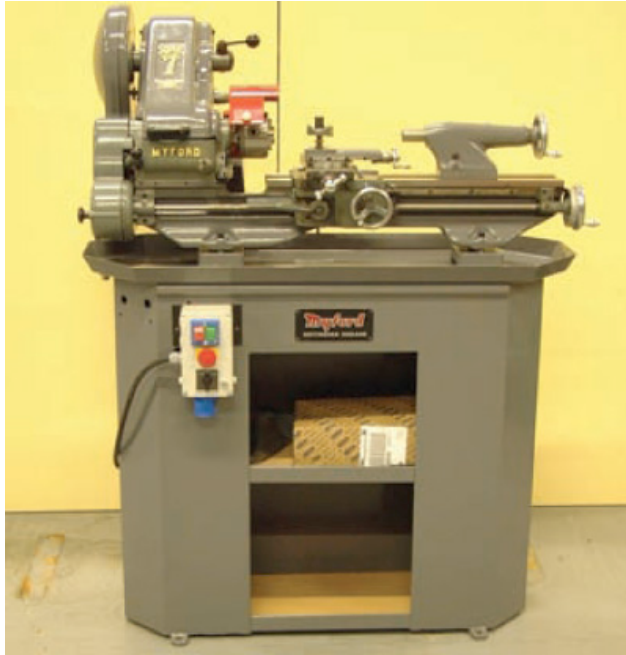
Photo 26
Back on its repainted cabinet stand, with new switchgear fitted, our reconditioned lathe awaits a new owner

Refitted to its newly refurbished cabinet stand and with modern switchgear (**Photo 26**), this rather sad example of this famous machine has been rejuvenated and is now ready for a new career in someone's workshop. Backed up by full factory guarantees, it will give many more years of good service.
